ON-SITE SCHOOL BUS INVESTIGATION

CASE NO. - 95-22
FLEET - CORPORATE SCHOOL BUS
LOCATION -
ACCIDENT DATE - 1995

This report concerns a motor vehicle incident involving a 1981 Ford B700, Type C, 64-Passenger, Conventional Body (body by _____ School Bus and a pedestrian (prior bus occupant) occurring in _____ 1995 at _____ in a county on a State road. This incident is of special interest because the school bus's convex cross view mirrors were improperly positioned and/or of insufficient size to adequately detect the presence of a child who, after departing the bus, was subsequently run over and fatally injured.

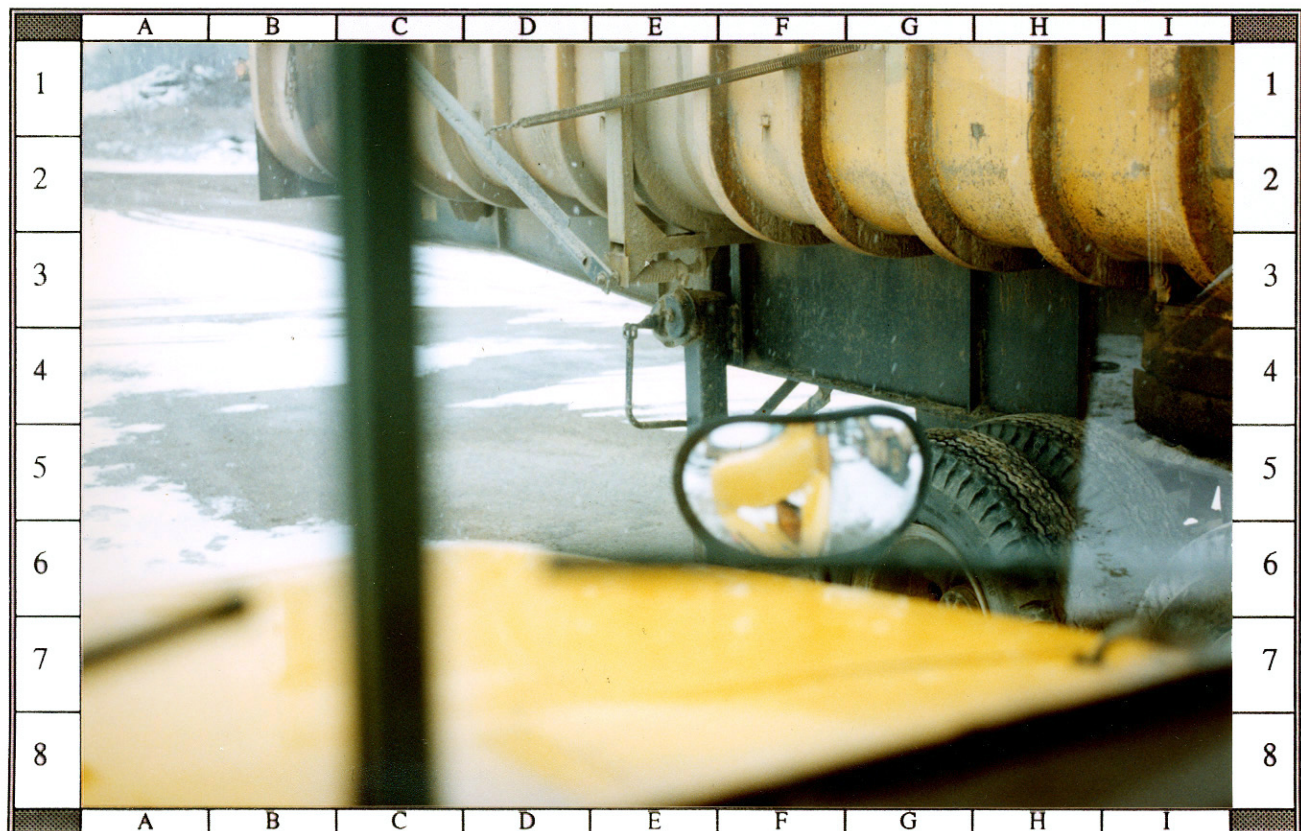
26: Case Vehicle driver's forward view through windshield of right third of bus's front; NOTE: windshield's center support bar and right wiper blade placement

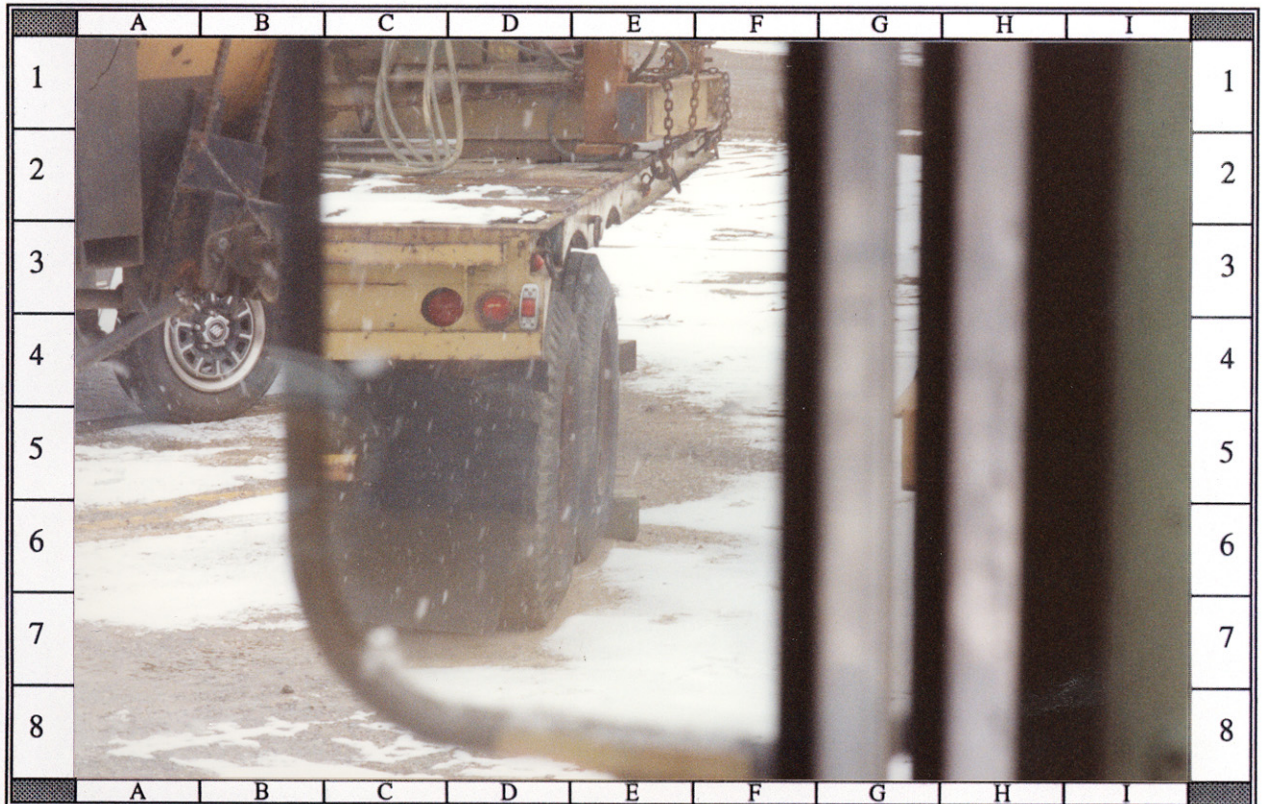
28: Telephoto view from Case Vehicle's driver seat through left, outside, unit magnification mirror; NOTE: test cones L and M are not visible

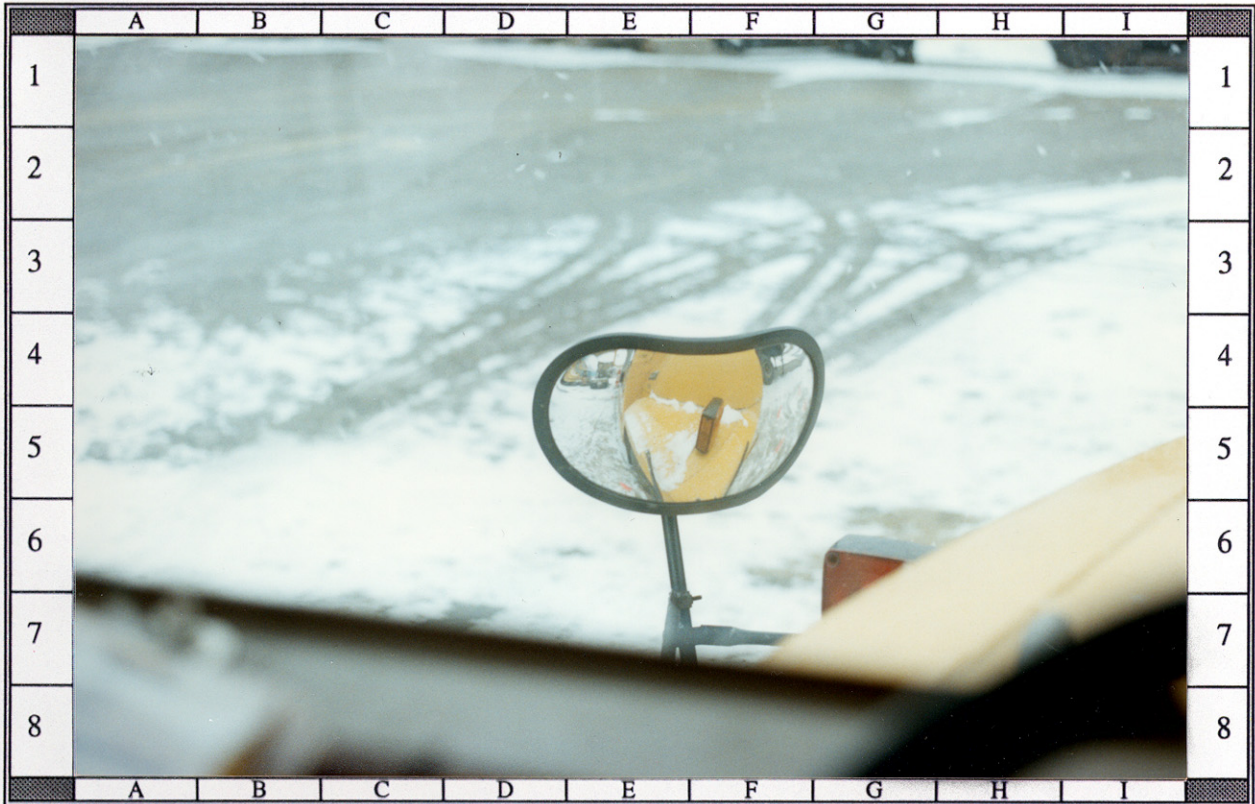
29: Normal view from Case Vehicle's driver seat through left, outside, convex, cross-view mirror

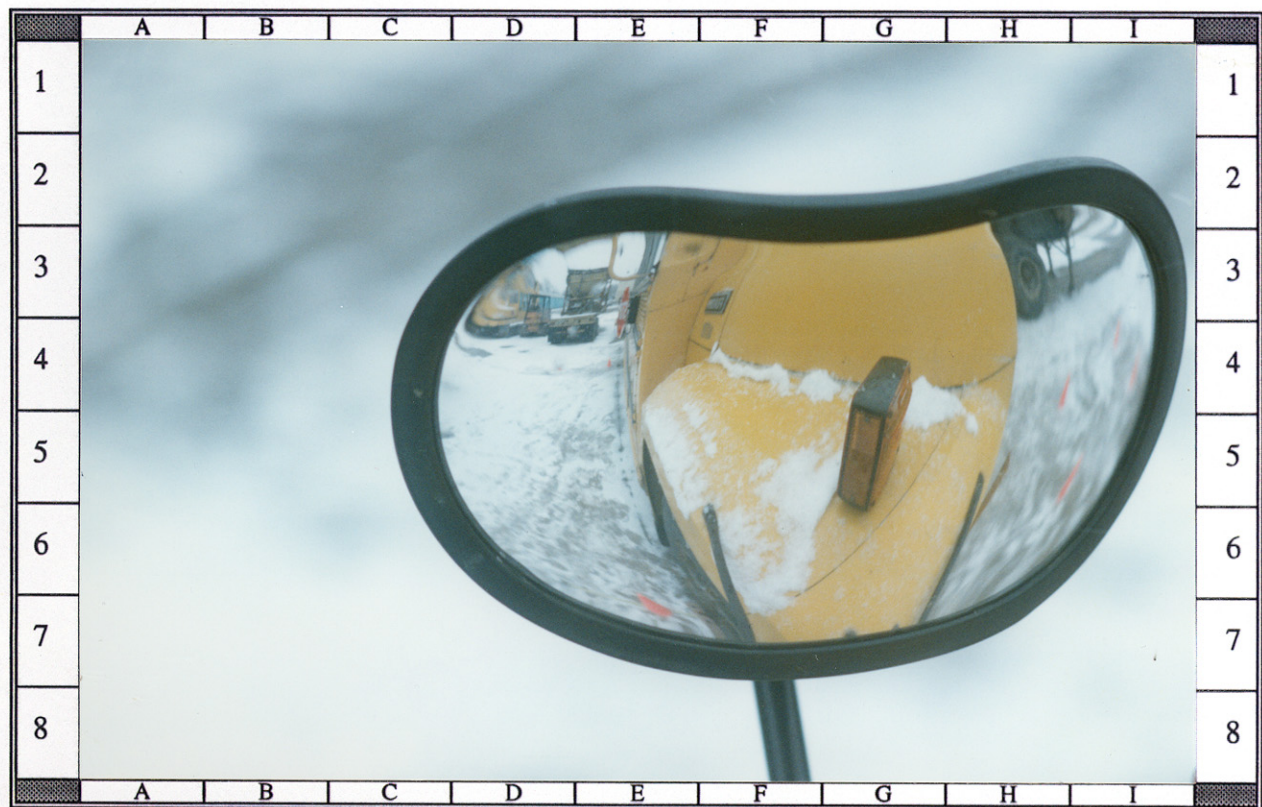
30: Normal view from Case Vehicle's driver seat through left, outside, convex, cross-view mirror with view moving left and up relative to steering wheel

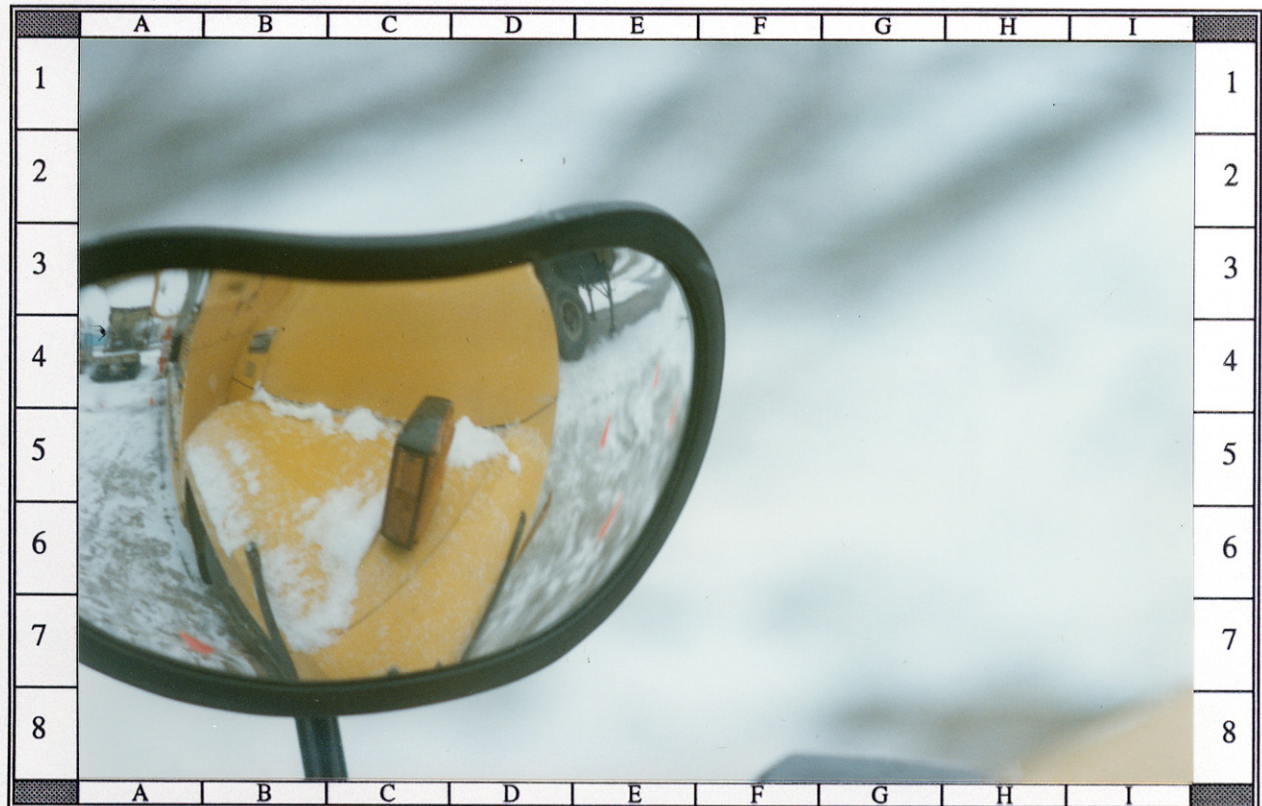
31: Telephoto view from Case Vehicle's driver seat through left, outside, convex, crossview mirror focusing down left side

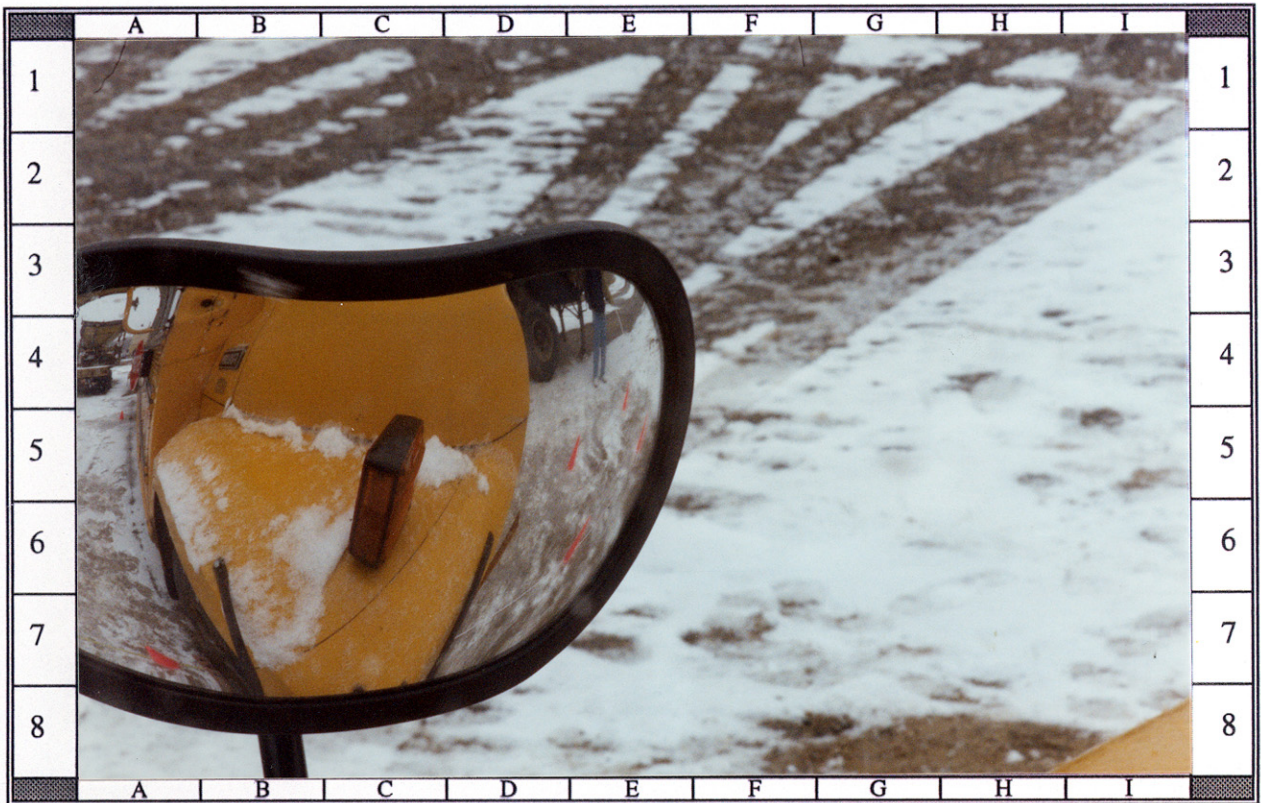
32: Telephoto view from Case Vehicle's driver seat through left, outside, convex, crossview mirror focusing across front

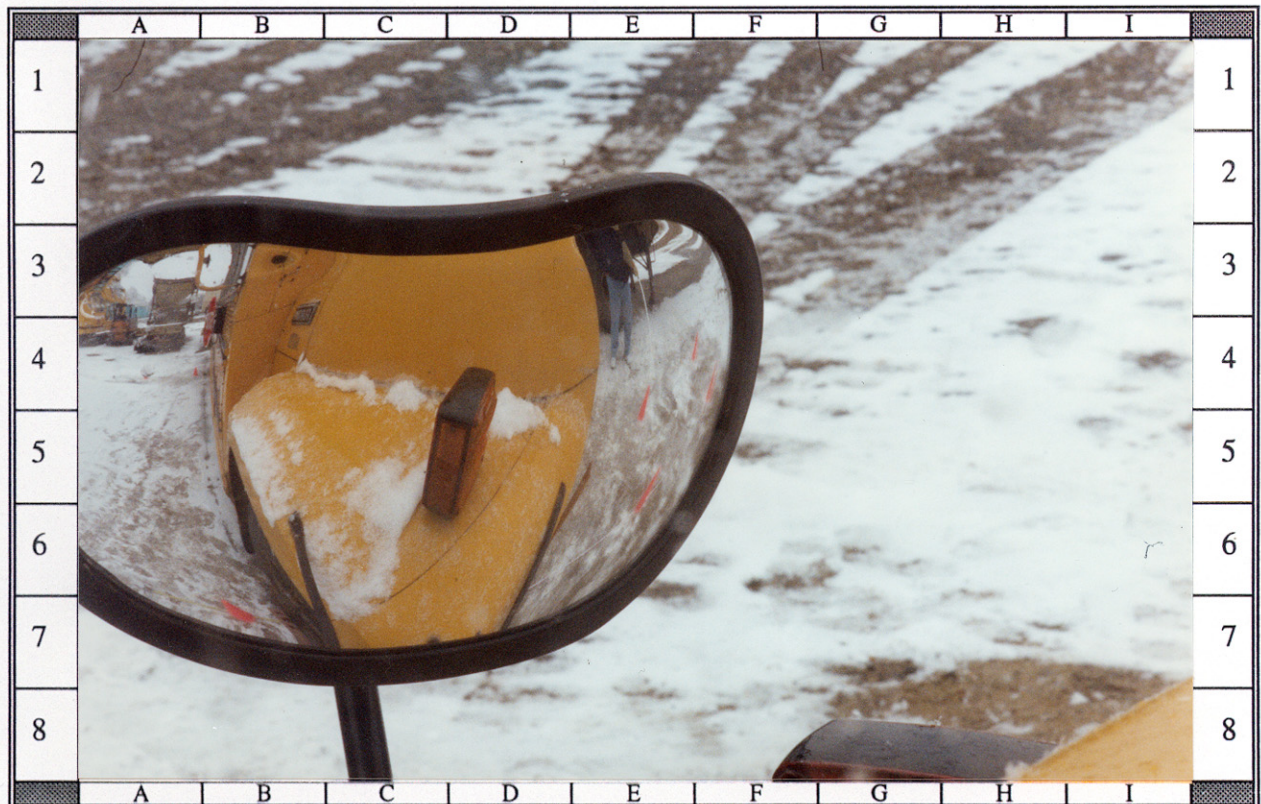
33: Telephoto view from Case Vehicle's driver seat through left, outside, convex, crossview mirror pointing to cone C and showing cones F, B, and E

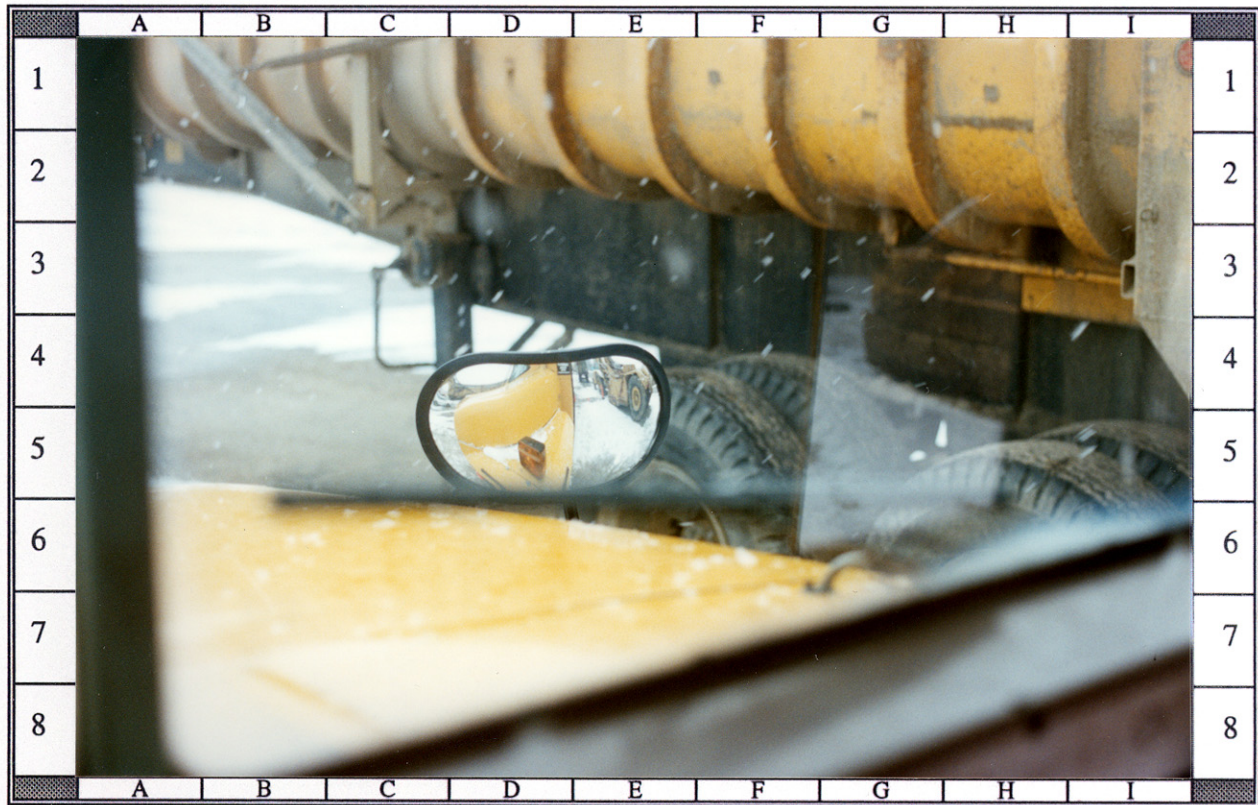
35: Normal view from Case Vehicle's driver seat through right, outside, convex, crossview mirror; NOTE: wiper could obstruct view of a shorter viewer

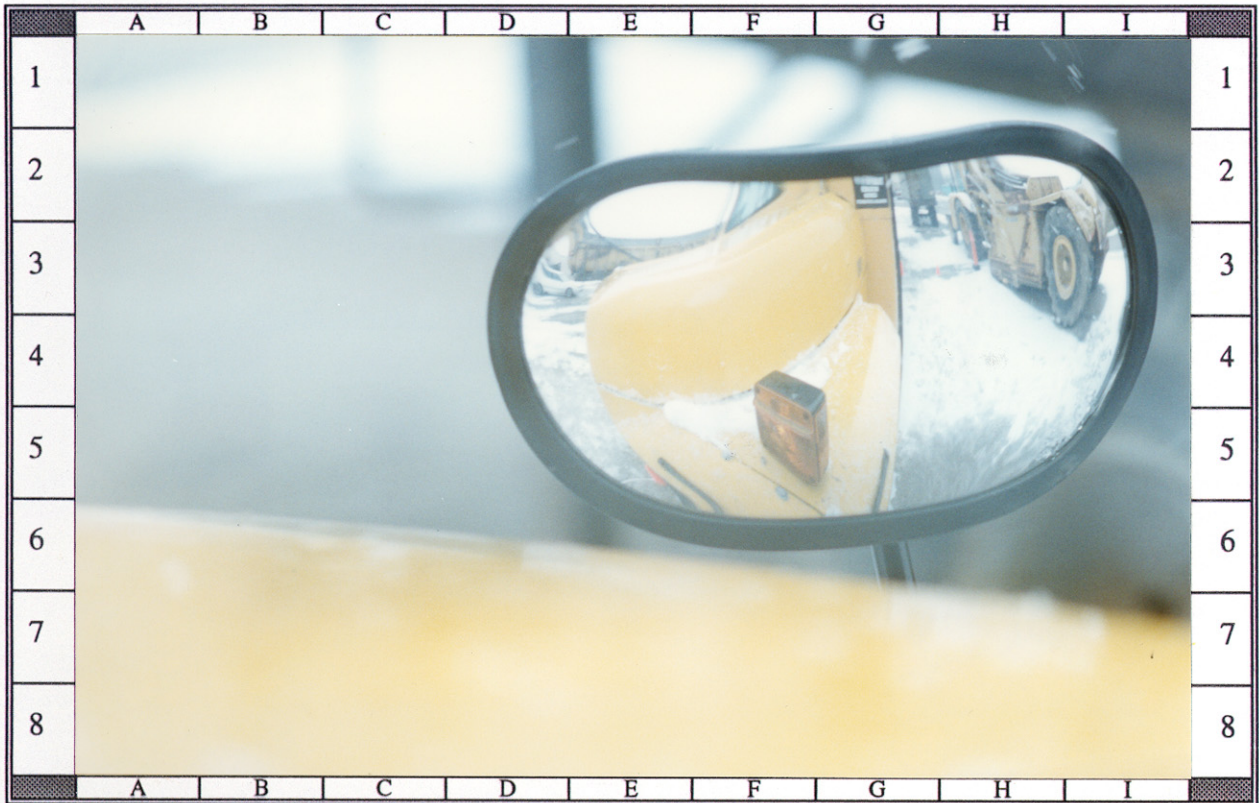
37: Telephoto view from Case Vehicle's driver seat through right, outside, convex, crossview mirror focusing across front; NOTE: only cone H visible

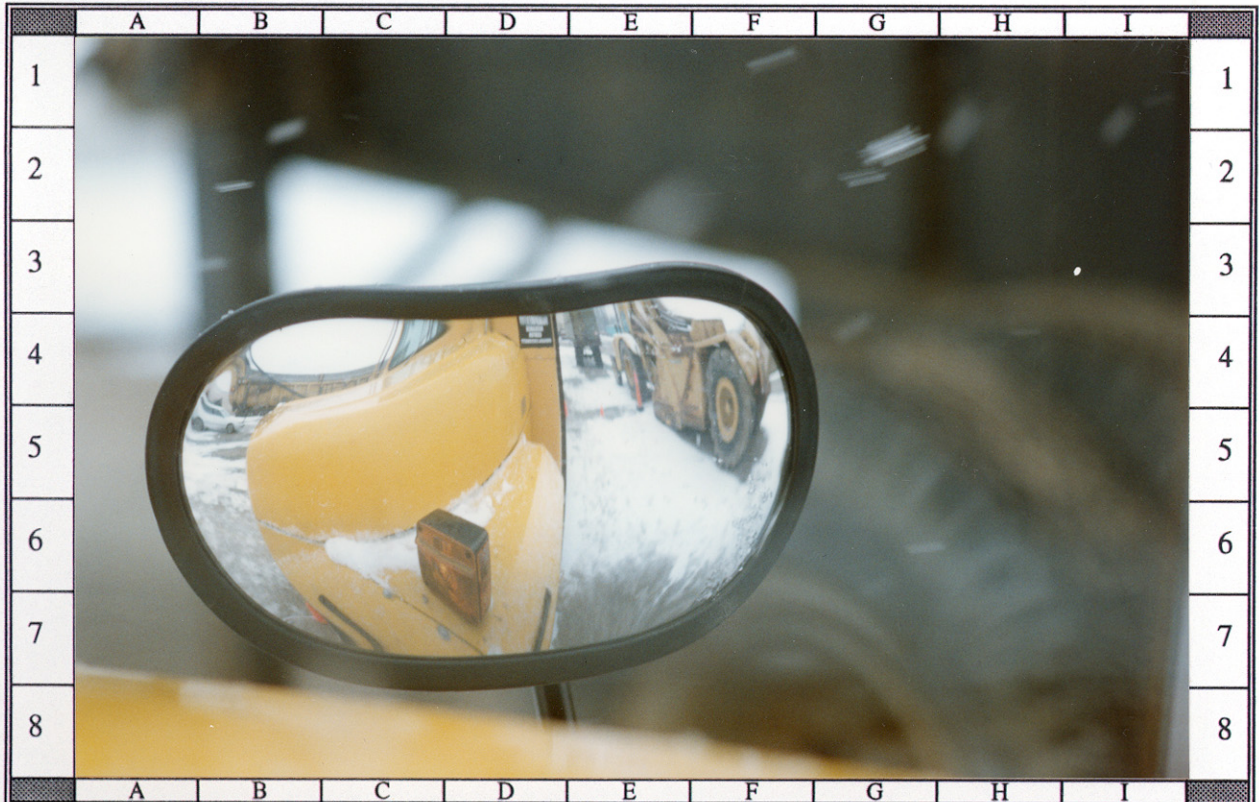
38: Telephoto view from Case Vehicle's driver seat through right, outside, convex, crossview mirror focusing down right side showing cones O and P

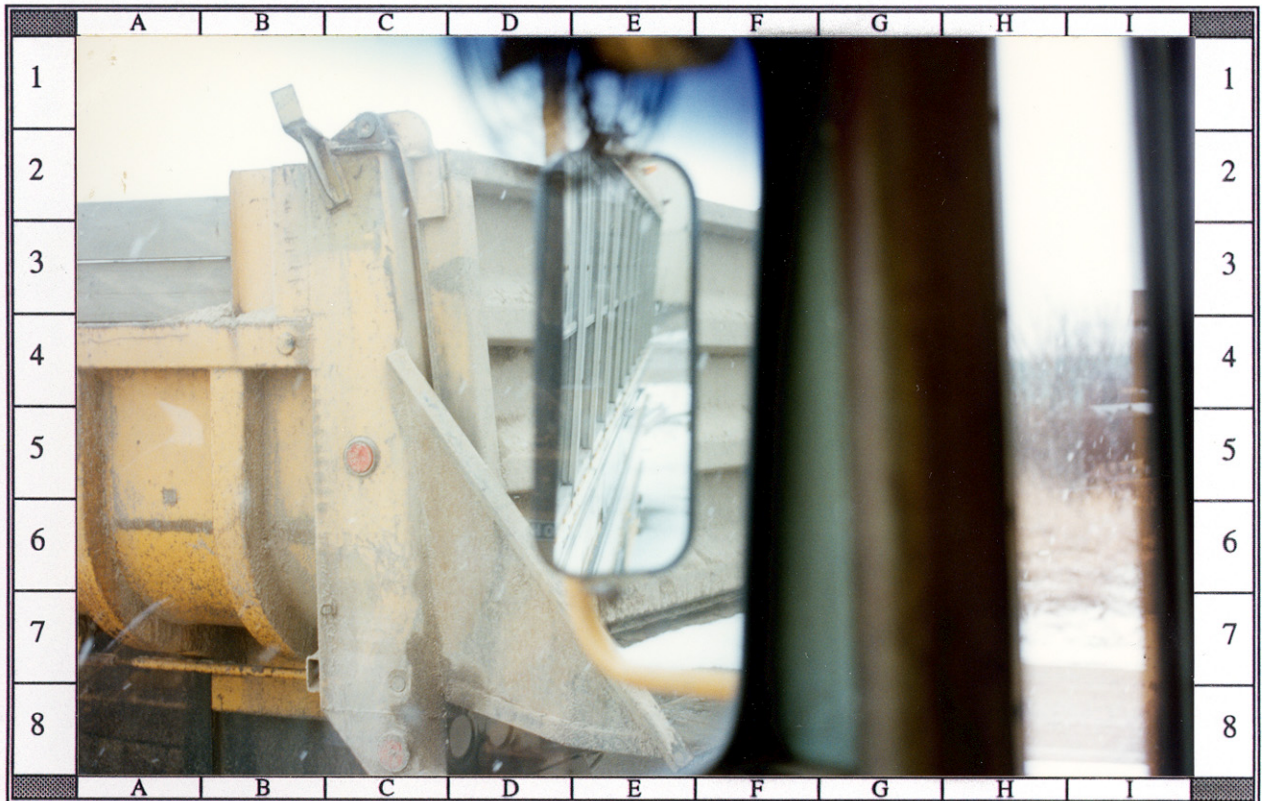
39: Normal view from Case Vehicle's driver seat through right, outside, unit magnification mirror; NOTE: no test cones are visible
